725D AND 725DA DISPENSE VALVE

TECH SUPPORT GUIDE

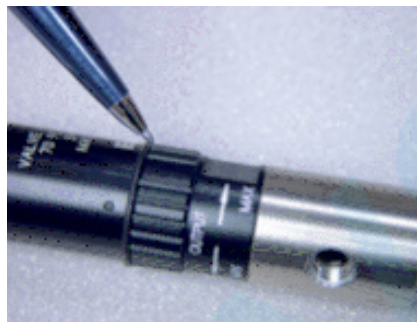
1

1. Turn the stroke adjustment collar to the maximum position.

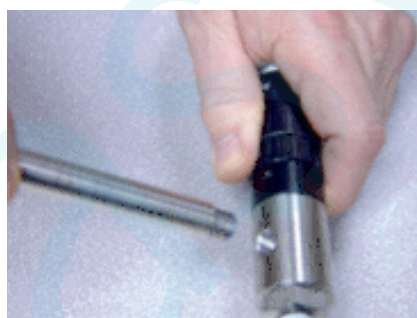
2

2. Install the 1/8 NPT rod in the fluid body mounting hole or fluid inlet.

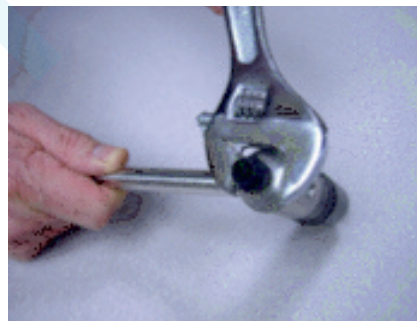
3

3. Holding the rod, use an 8" adjustable wrench to remove the fluid body cap.

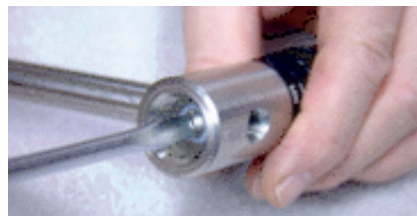
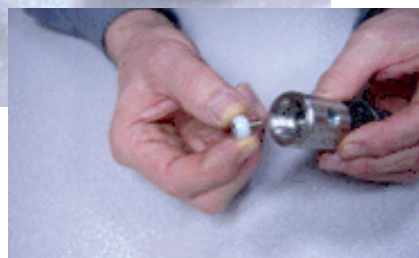
4

4. Using the flat tip screwdriver, remove the sealing head and screw.

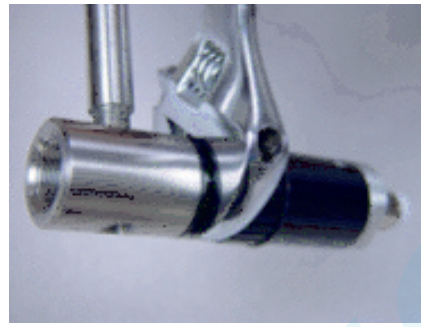
5

- 5. Holding the rod, use one of the 8" adjustable wrenches to loosen the fluid body.**

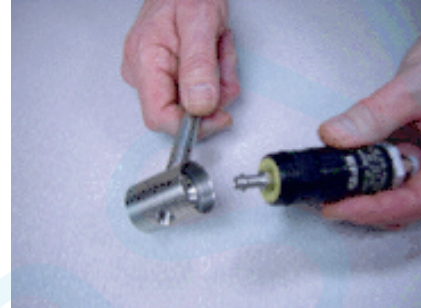
6

- 6. Remove the fluid body from the air cylinder.**

At this point, the fluid end of the valve can be thoroughly cleaned without further disassembly.

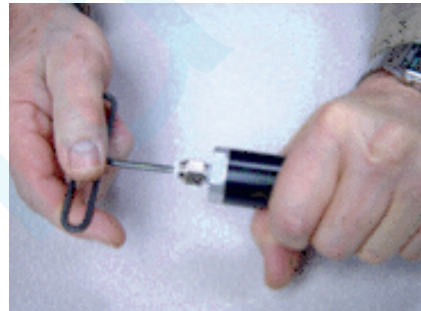
7

- 7. Insert the 1/8" hex wrench through the air inlet fitting, loosen the shaft locking screw, and turn it out two full turns.**

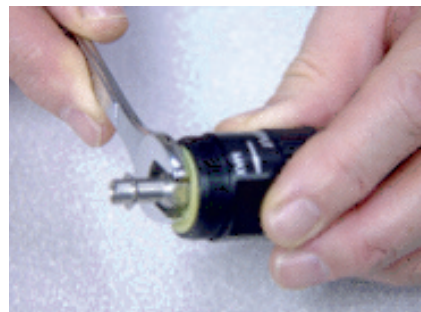
8

- 8. Using the 3/8" open-end wrench, loosen the shaft.**

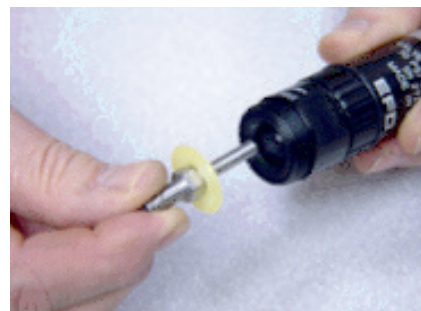
9

- 9. Remove the shaft and diaphragm.**

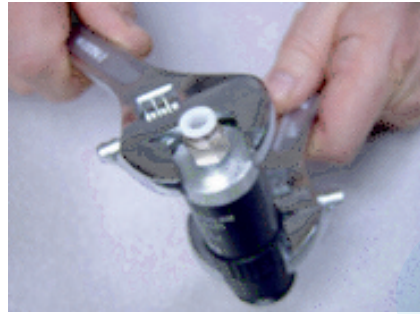
10

10. Place one 8" adjustable wrench on the air cylinder flats and the other 8" adjustable wrench on the cylinder cap flats, and loosen the cylinder cap.

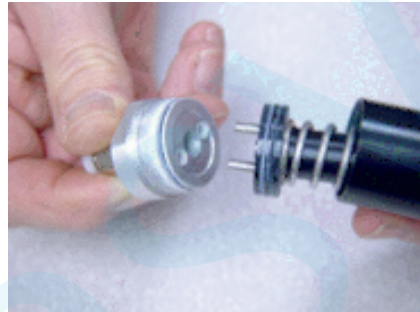
11

11. Remove the cylinder cap, piston and spring from the air cylinder.

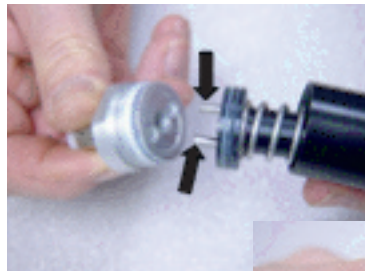
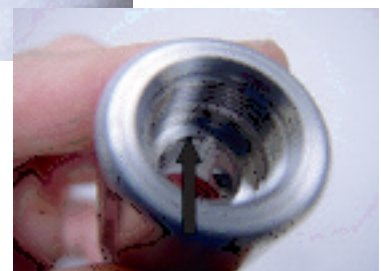
1

1. Clean and inspect all parts

- Clean all parts with a solvent that is compatible with the fluid being dispensed.
- Inspect all threads.
- Inspect piston pins for straightness.
- Inspect fluid body seat area for pitting.
- Replace all worn or damaged parts.
- Complete parts lists appear on the last page of these instructions.

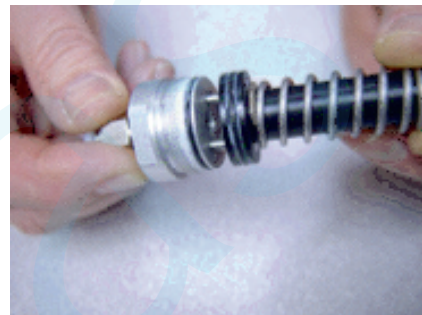
3

3. Assemble the air cylinder cap, piston and spring.

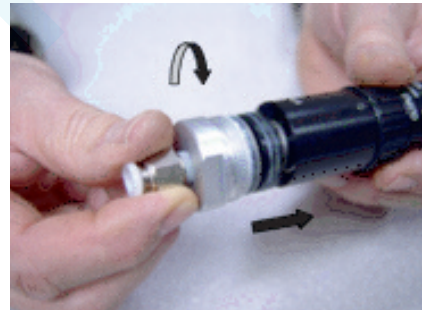
4

4. Install the air cylinder cap, piston and spring by pushing to compress the spring while turning to engage the threads.

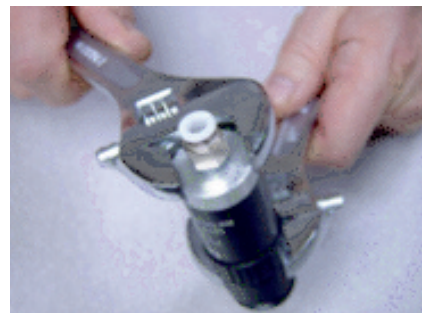
5

5. Using the two 8" adjustable wrenches, tighten the air cylinder cap. If a torque wrench is available, torque to 10.8 Nm (8 ft lbs).

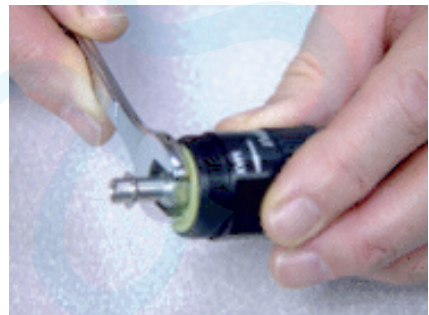
7

7. Using the 3/8" open-end wrench, tighten the shaft. If a torque wrench is available, torque to 1.69 Nm (15 in lbs).

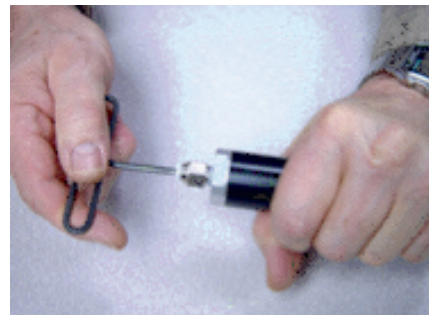
8

8. Insert the 1/8" hex wrench through the air inlet fitting and tighten the shaft locking screw. If a torque wrench is available, torque to 2.82 Nm (25 in lbs).

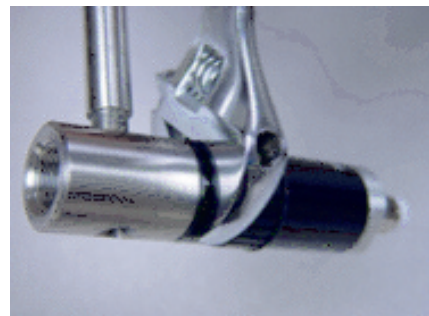
9. Install the fluid body and tighten using the 1/8 NPT rod and 8" adjustable wrench. If a torque wrench is available, torque to 6.78 Nm (5 ft lbs).

Leaking at vent hole: Disassemble the valve and review Steps 7 – 9 to make sure the shaft and fluid body are tight.

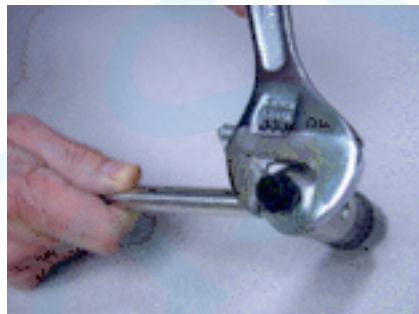
11

11. Install and tighten the fluid body cap using the 1/8 NPT rod and 8" adjustable wrench. Remove the 1/8 NPT rod.
